## EUREKA FURNISHINGS REPORT

### Introduction

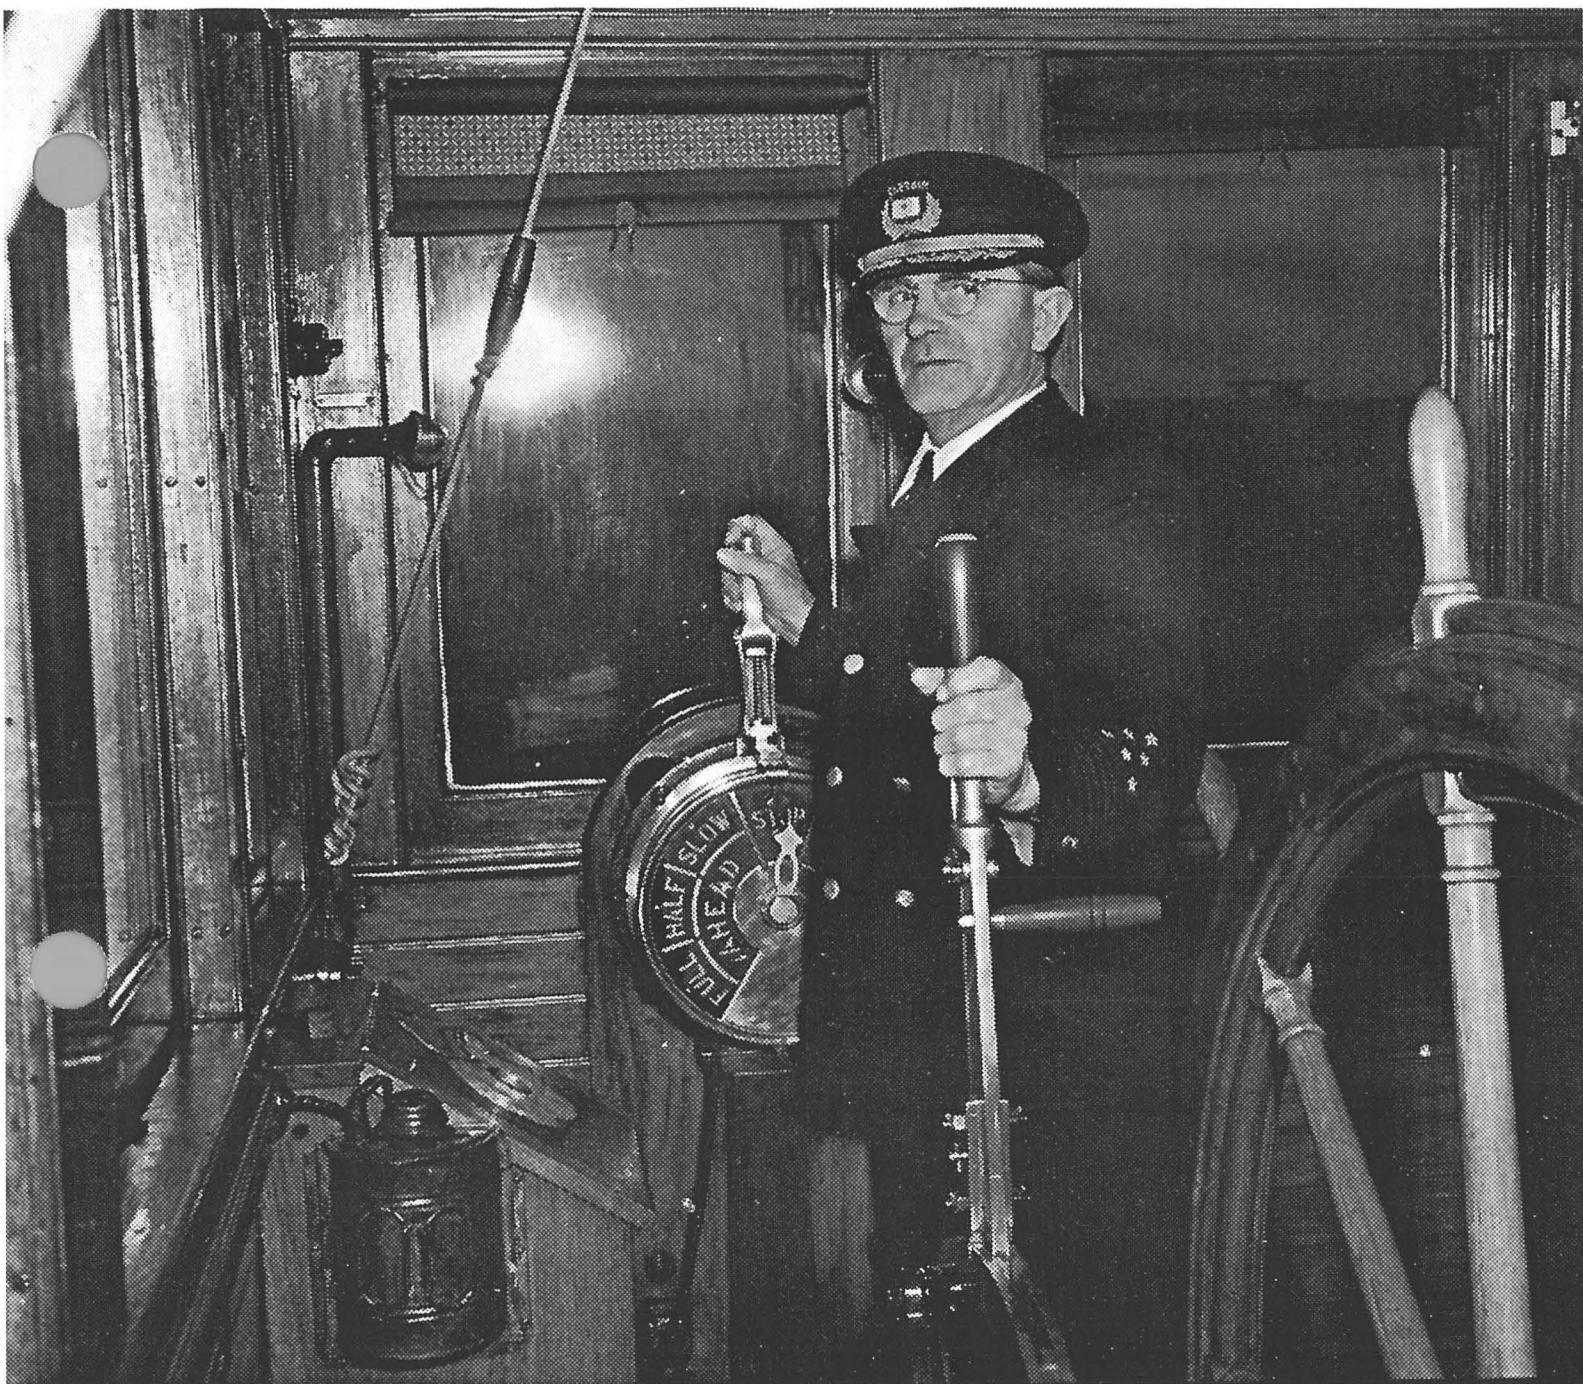
The photo shown here is not the EUREKA, but it is a photo of another Northwestern Pacific ferry that was in operation at the same period as the EUREKA. It is the only known photo that shows both the steam powered tiller and the manual steering wheel, aboard one of the NWP ferry boats.

"Captain Alfred Wahrgren stands at the steam tiller in the wheelhouse of the CAZADERO. The wooden steering wheel, no longer in use at the time the picture at left [above] was taken, was detached from the steering gear so that the spinning handles would not endanger someone in the pilothouse."  
SF Bay Ferryboats, Harlan page 77.

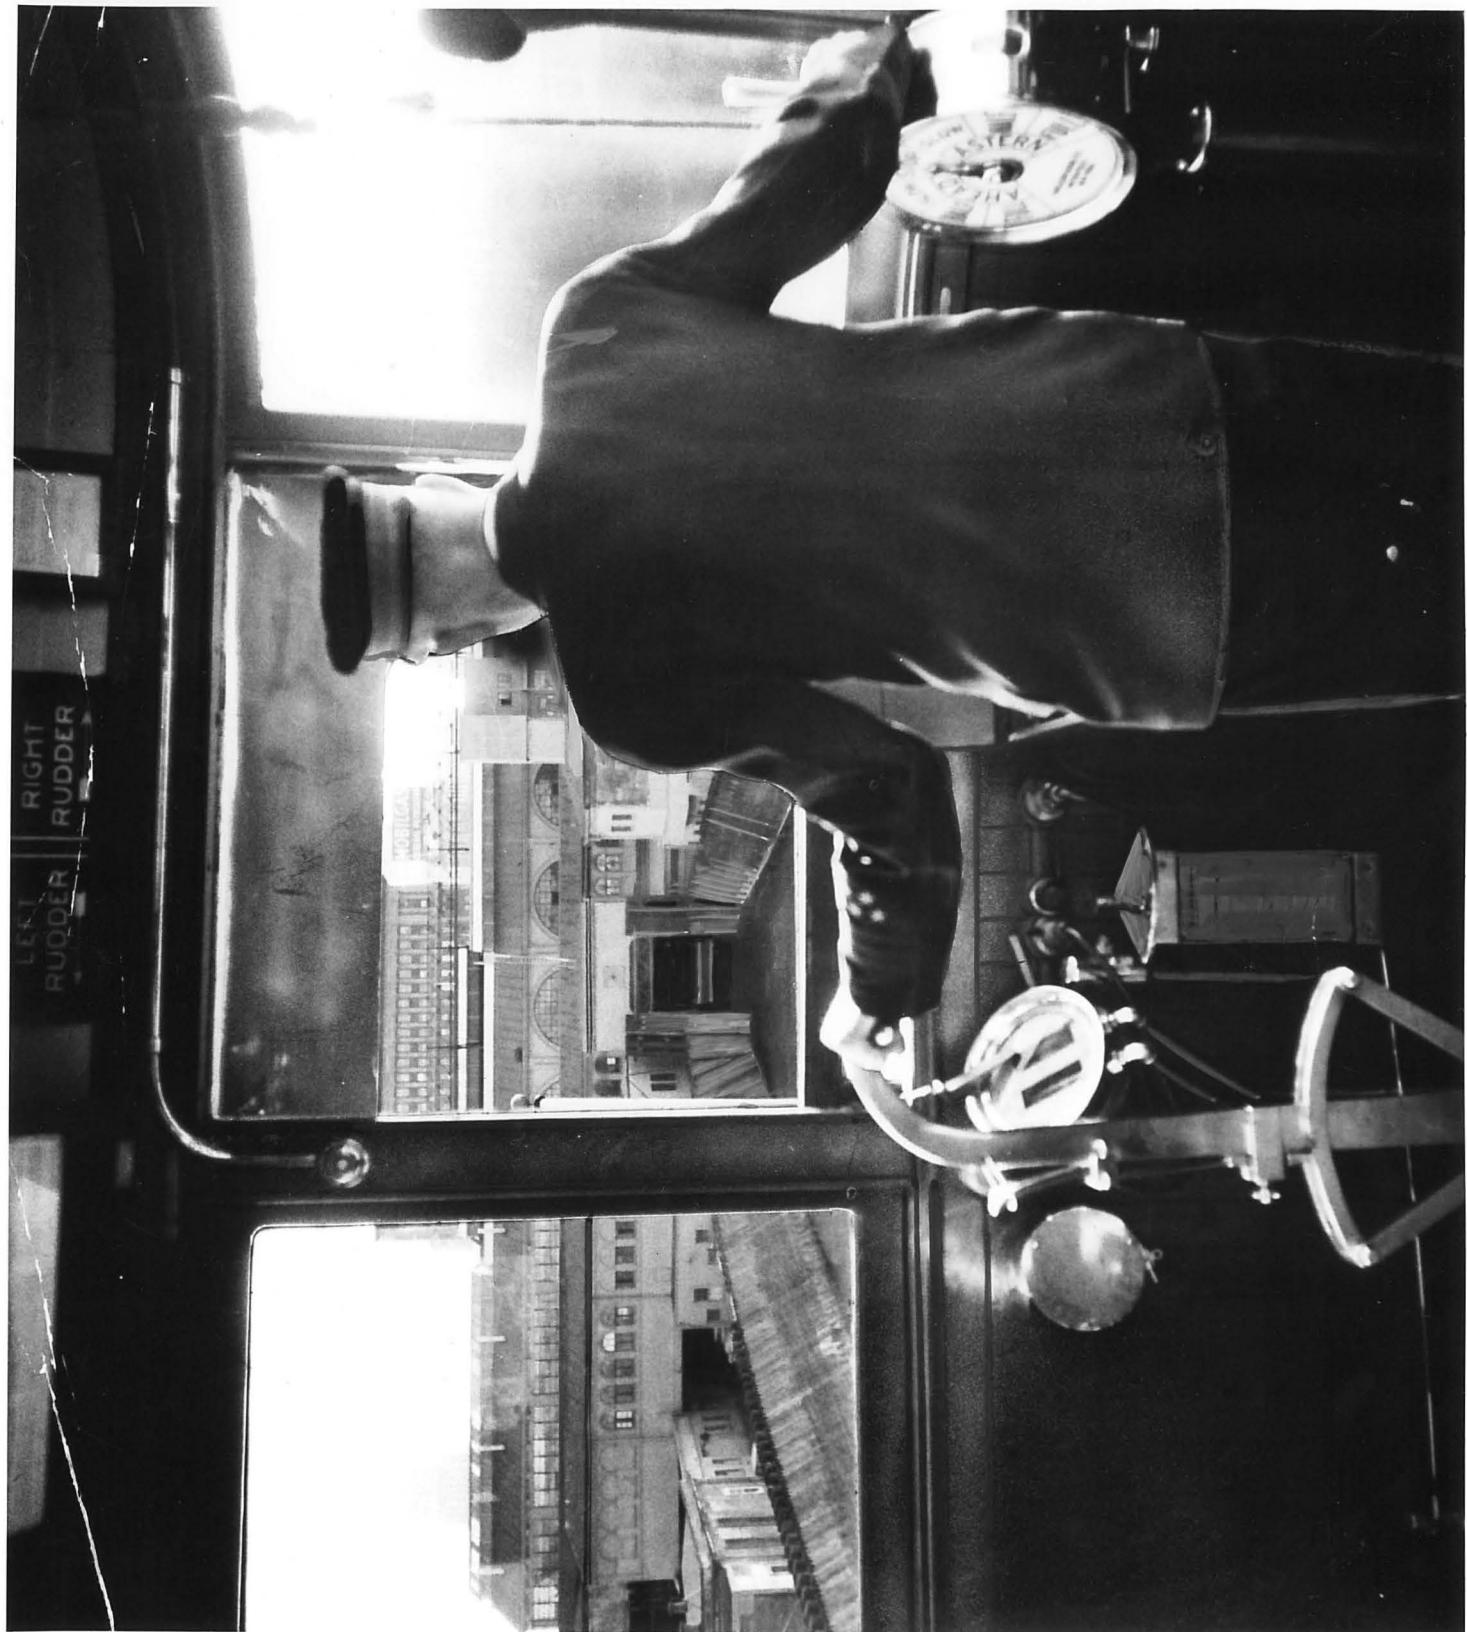
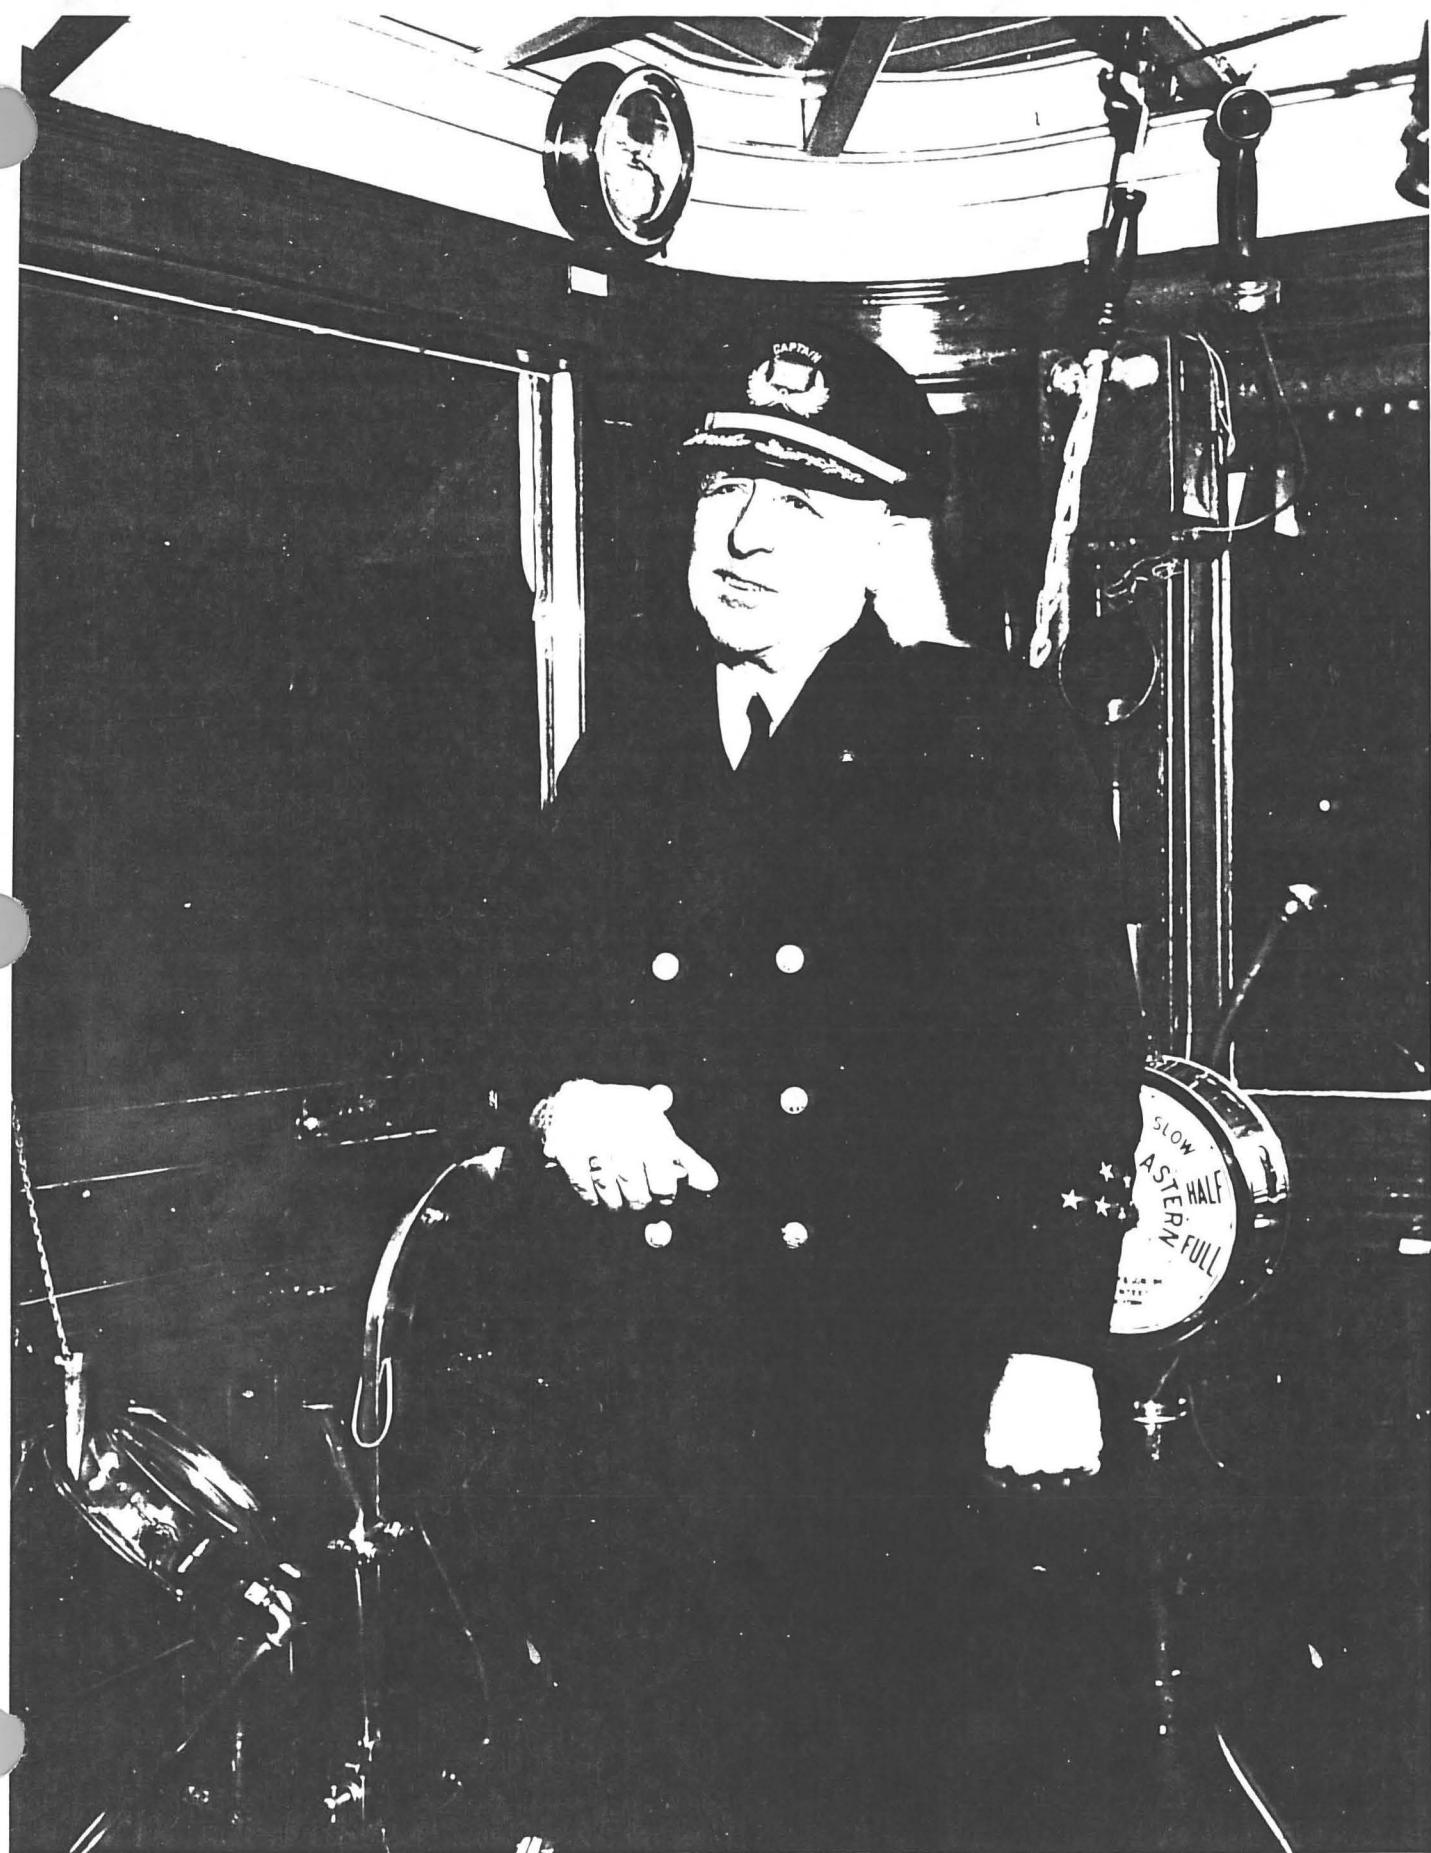
Possible Wheel

Building E - North End

Modern Replica Wheel

about 60" over the handles  
mahogany and in laid woods

SAFR 11392
